ASBESTOS AND DETERIORATED LEAD-CONTAINING PAINT SURVEY

LA FONDA AVENUE OVERCROSSING SANTA CRUZ, CALIFORNIA

GEOCON PROJECT NO. E8461-06-01
CALTRANS EA 05-0F6500

Subject: ASBESTOS AND DETERIORATED LEAD-CONTAINING PAINT SURVEY
LA FONDA AVENUE OVERCROSSING (BRIDGE 36-0018)
SANTA CRUZ, CALIFORNIA

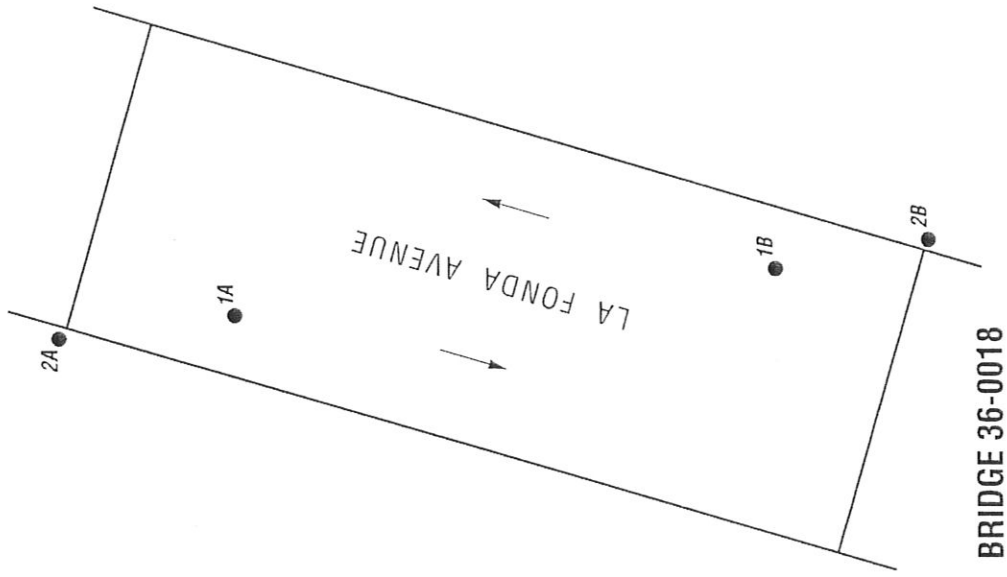
SITE PLAN

Sample identification numbers, material descriptions, approximate quantities, friability assessments, and photo references are summarized on the attached table. Approximate sample locations are presented on Figure 2. Materials represented by the samples collected are shown in the attached photographs.

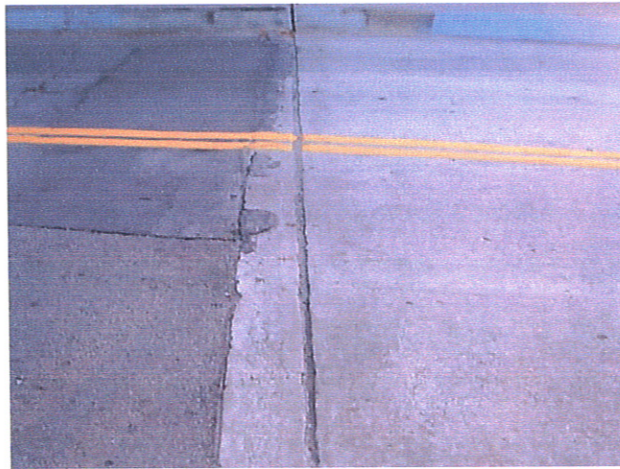
Photo 2 – Deck joint seal (non-suspect)

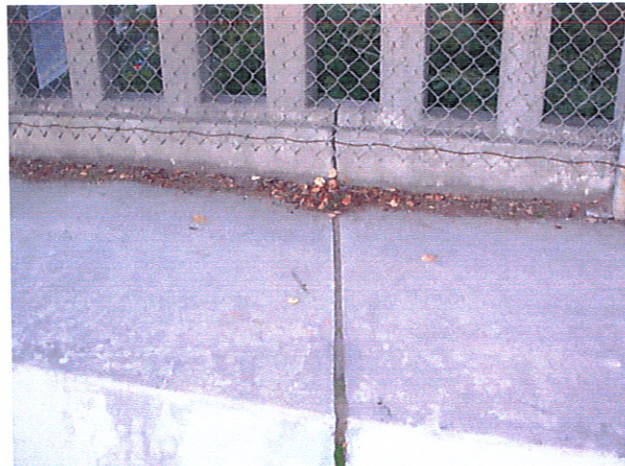
Photo 3 – Span joint fill material

Sample ID	Description of Suspect Material	Approximate Quantity	Friable	Site Photo	Asbestos Content
1A	Expansion joint fill material (span)	NA	NA	3	ND
1B					ND
2A	Expansion joint fill material (abutments)	NA	NA	5	ND
2B					ND

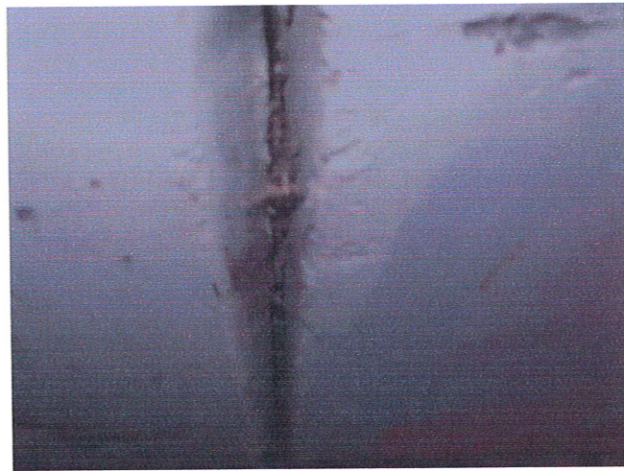
Photo 5 – Abutment joint fill material
